DEPARTMENT OF TRANSPORTATION

Quality Assurance and Source Inspection

Contract #: 04-0120F4Cty: SF/ALA Rte: 80 PM: 13.2/13.9File #: 69.28**WELDING INSPECTION REPORT****Resident Engineer:**Pursell, Gary**Address:** 333 Burma Road**City:** Oakland, CA 94607**Report No:** WIR-016362**Date Inspected:** 09-Aug-2010**Project Name:** SAS Superstructure**OSM Arrival Time:** 700**Prime Contractor:** American Bridge/Fluor Enterprises, a JV**OSM Departure Time:** 1900**Contractor:** Zhenhua Port Machinery Company, Ltd (ZPMC), Changxing Island **Location:** Shanghai, China**CWI Name:** Qiu Wen**CWI Present:** Yes No**Inspected CWI report:** Yes No N/A**Rod Oven in Use:** Yes No N/A**Electrode to specification:** Yes No N/A**Weld Procedures Followed:** Yes No N/A**Qualified Welders:** Yes No N/A**Verified Joint Fit-up:** Yes No N/A**Approved Drawings:** Yes No N/A**Approved WPS:** Yes No N/A**Delayed / Cancelled:** Yes No N/A**Bridge No:** 34-0006**Component:** Tower & OBG Components**Summary of Items Observed:**

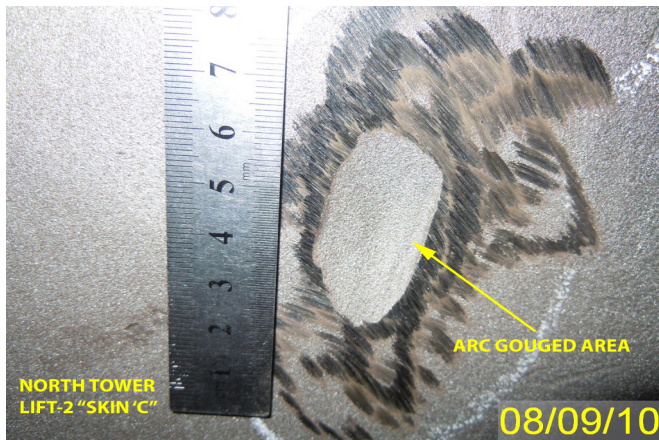
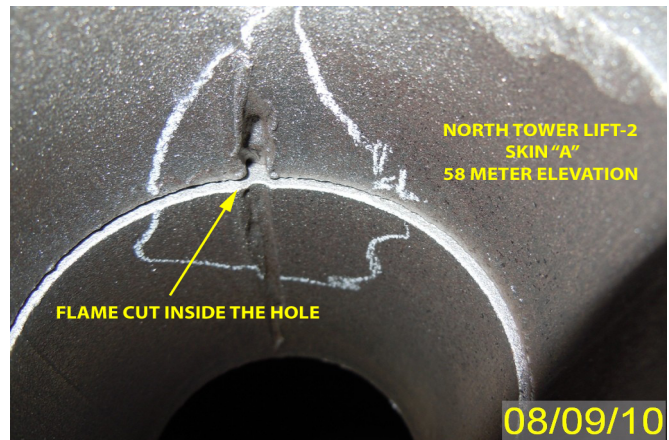
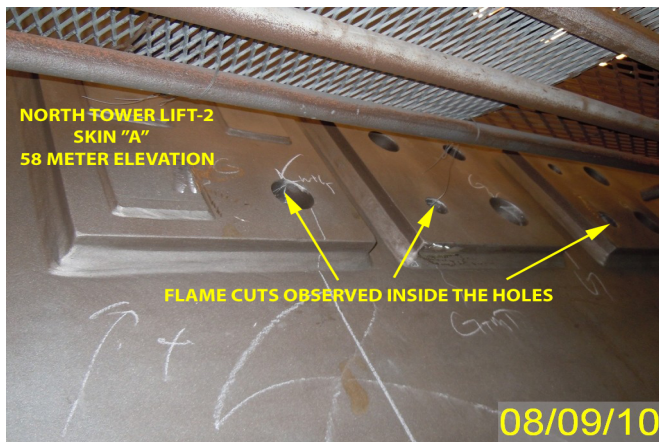
During the external pre-blast visual inspection of north tower lift-2, this Quality Assurance Inspector (QA) discovered the defects required welding and Magnetic particle testing on base material at the following locations:

- Skin 'A' – Notch – 5 mm from top of the tower.
- Skin 'A' – Flame cut – Inside the holes at 58 Meter elevation.
- Skin 'C' – arc gouge – at 68 Meter elevation.
- Skin 'D' – Notch – 200 mm from top of the tower.
- Skin 'E' – arc gouge – 3880 mm from Bottom of the tower.

For further more information see attached pictures
